FINAL SUMMARY TECHNICAL REPORT

BUREAU OF NAVAL WEAPONS RRMA-232

MATERIALS PROCESSING DEPARTMENT

DESIGN DATA STUDY FOR
COATED COLUMBIUM ALLOYS

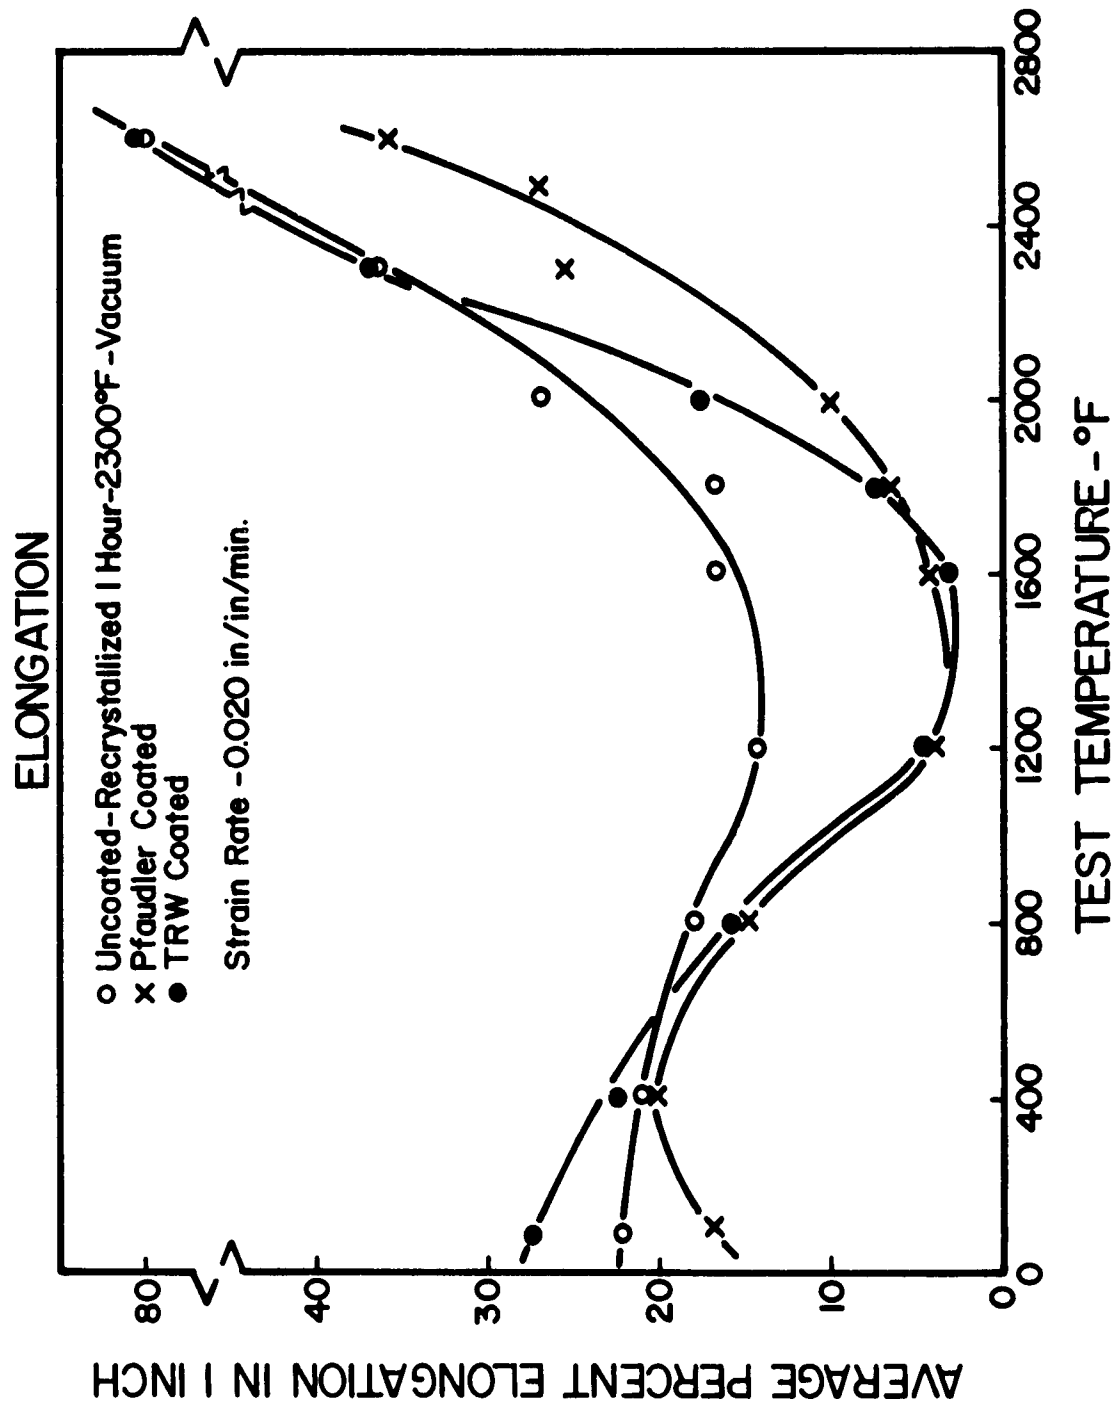
Figure 39 Tensile Elongation of Uncoated and Coated 30 Mil FS-85 Alloy Sheet
Tested from Room Temperature to 2600°F

uncoated FS-85 alloy was also a region of minimum base metal ductility for both the uncoated and coated material, as evidenced by both the elongation and reduction in area measurements. This change in the characteristics of the strength and ductility curves resulting from the coating may be attributed to both the coating application thermal treatment and to the presence of a brittle surface layer. Cracks produced in the coating after small amounts of deformation would impose severe surface notches in the gage section, in the vicinity of which there would be effectively higher strain rates than that experienced by the uncoated material during uniform deformation. This could result in the propagation of cracks through the substrate reducing the overall ductility. However, if this alteration in properties was totally a notch effect, it is not clear why the brittle behavior of the coated sheet was exhibited in the 1200-1800°F temperature range and not at the lower temperatures where notch effects produced by stress cracks in the coating should be more marked. This behavior tends to indicate the coated substrate became more notch sensitive at the intermediate test temperatures than at lower temperatures.

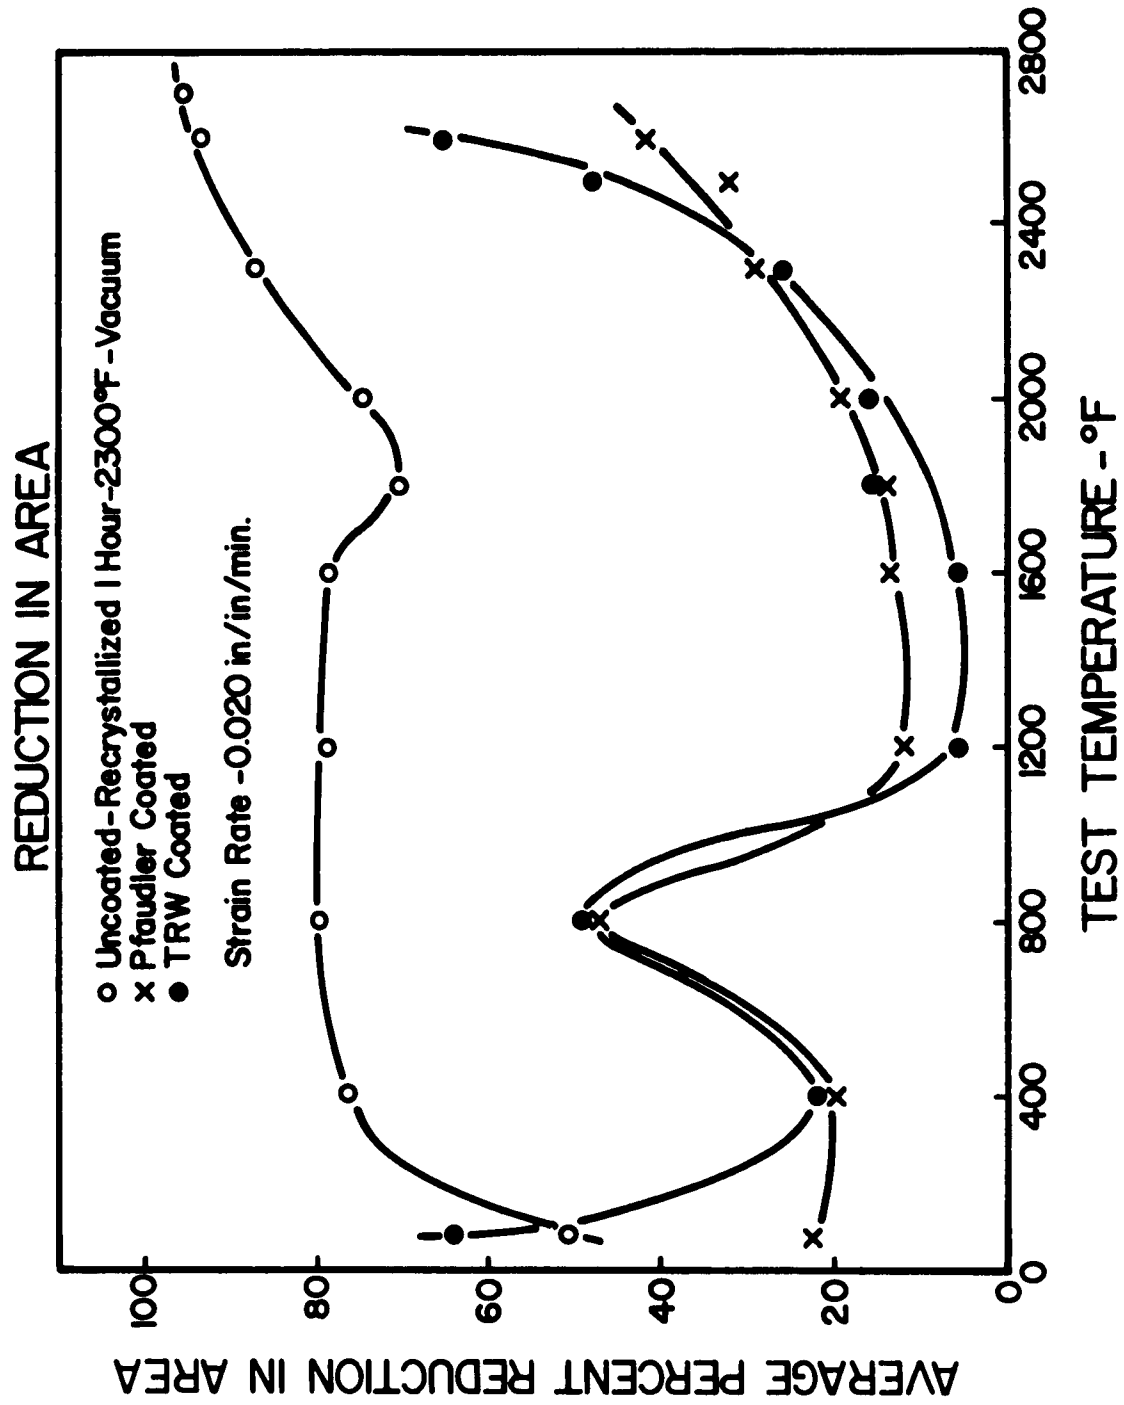
Figure 40 Reduction in Area of Uncoated and Coated 30 Mil FS-85 Alloy Sheet
Tensile Tested from Room Temperature to 2600°F

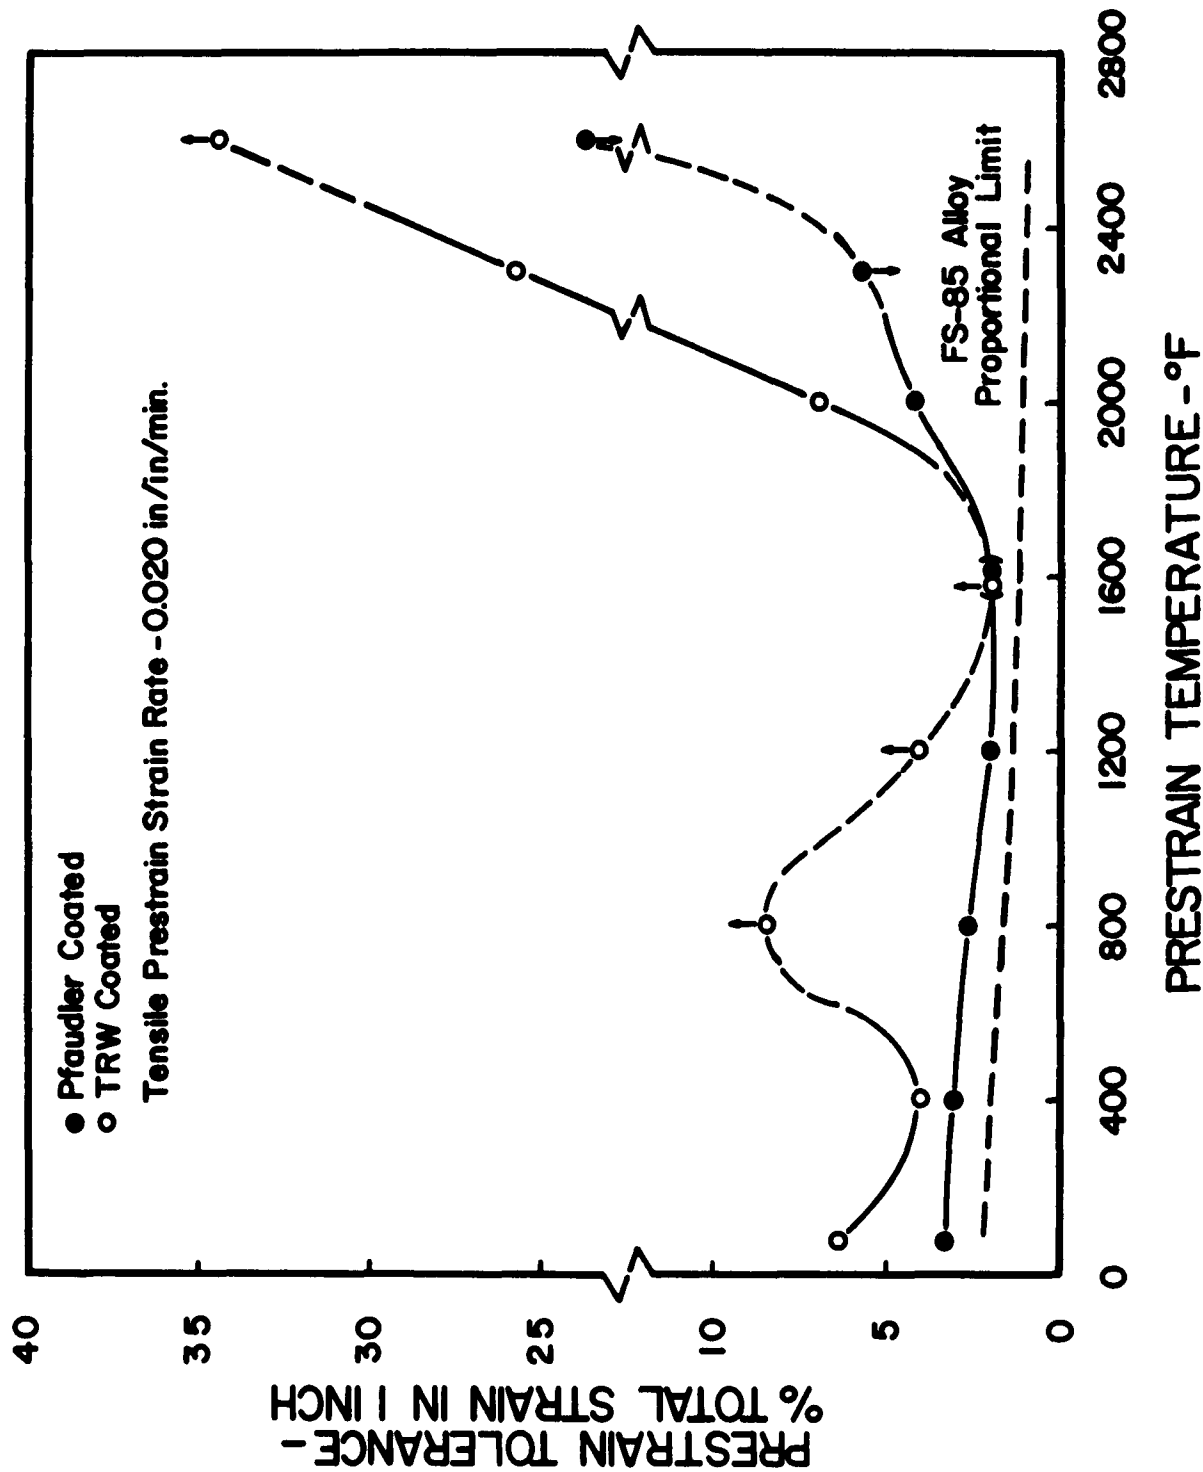
Figure 42 Limit of Coating-Base Metal Deformation at Various Prestrain Temperatures Without Loss of 2 Hour Post Oxidation Protection at 1600°F for Pfaudler and TRW Coated FS-85 Alloy

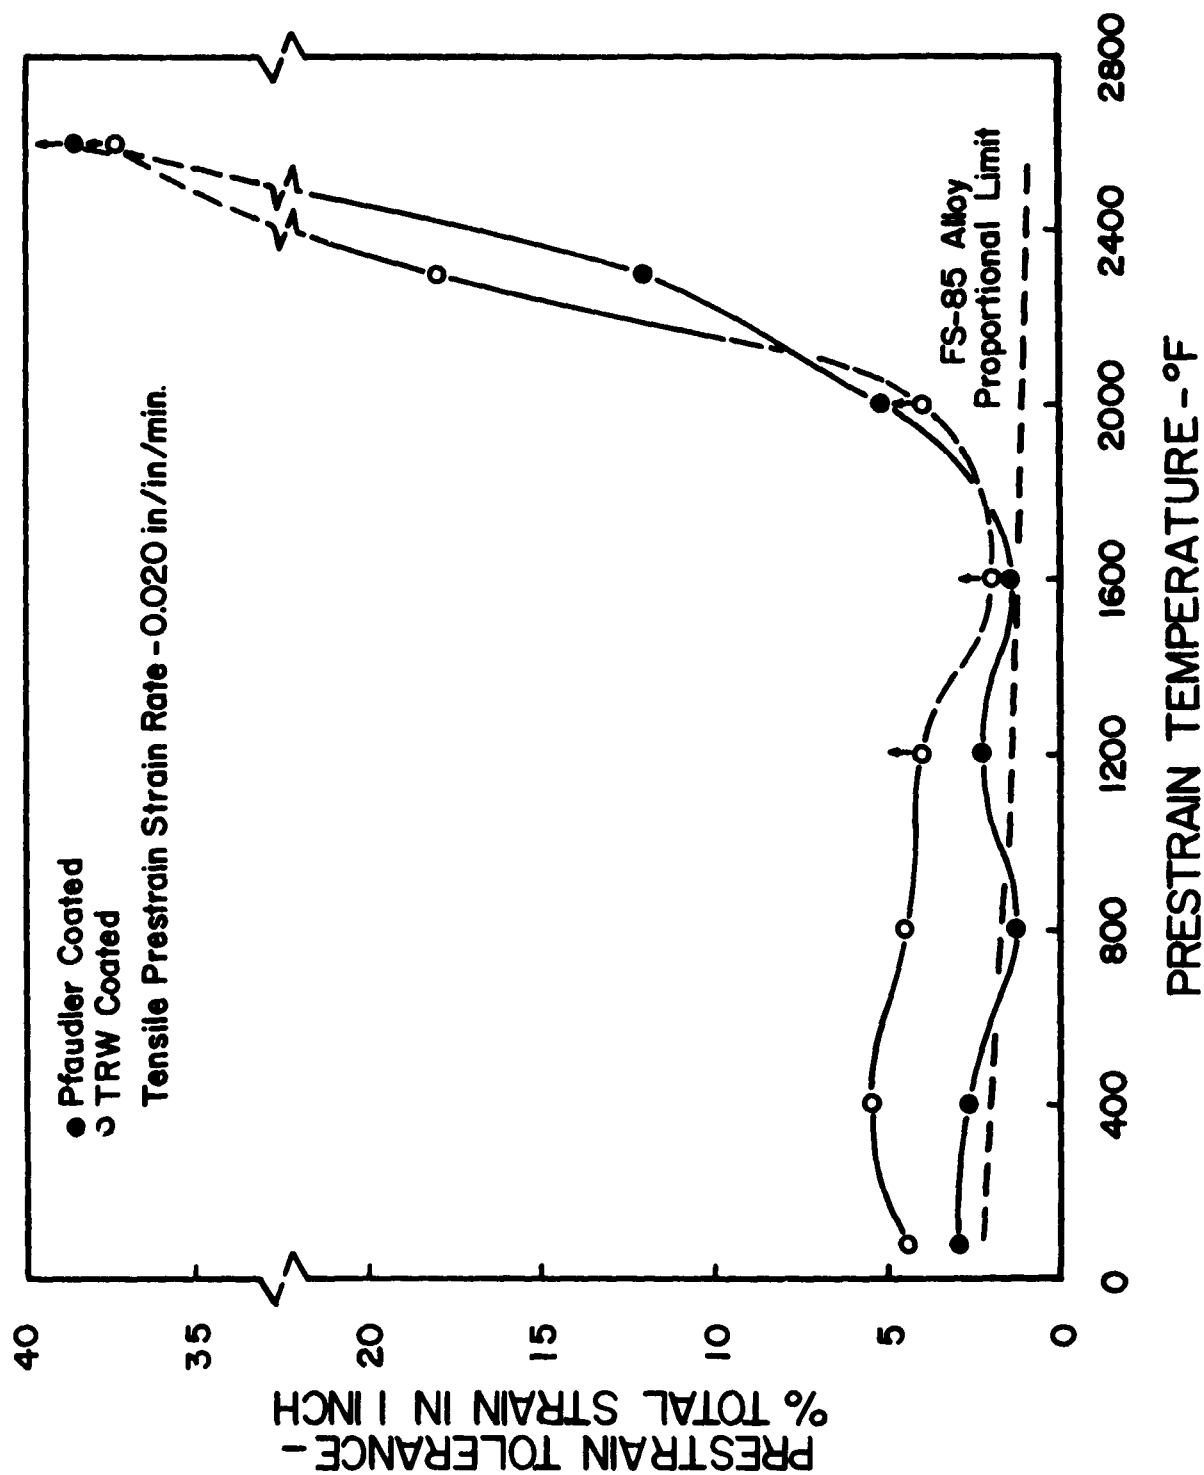
Figure 43 Limit of Coating-Base Metal Deformation at Various Prestrain Temperatures Without Loss of 2 Hour Post Oxidation Protection at 2600°F for Pfaudler and TRW Coated FS-85 Alloy

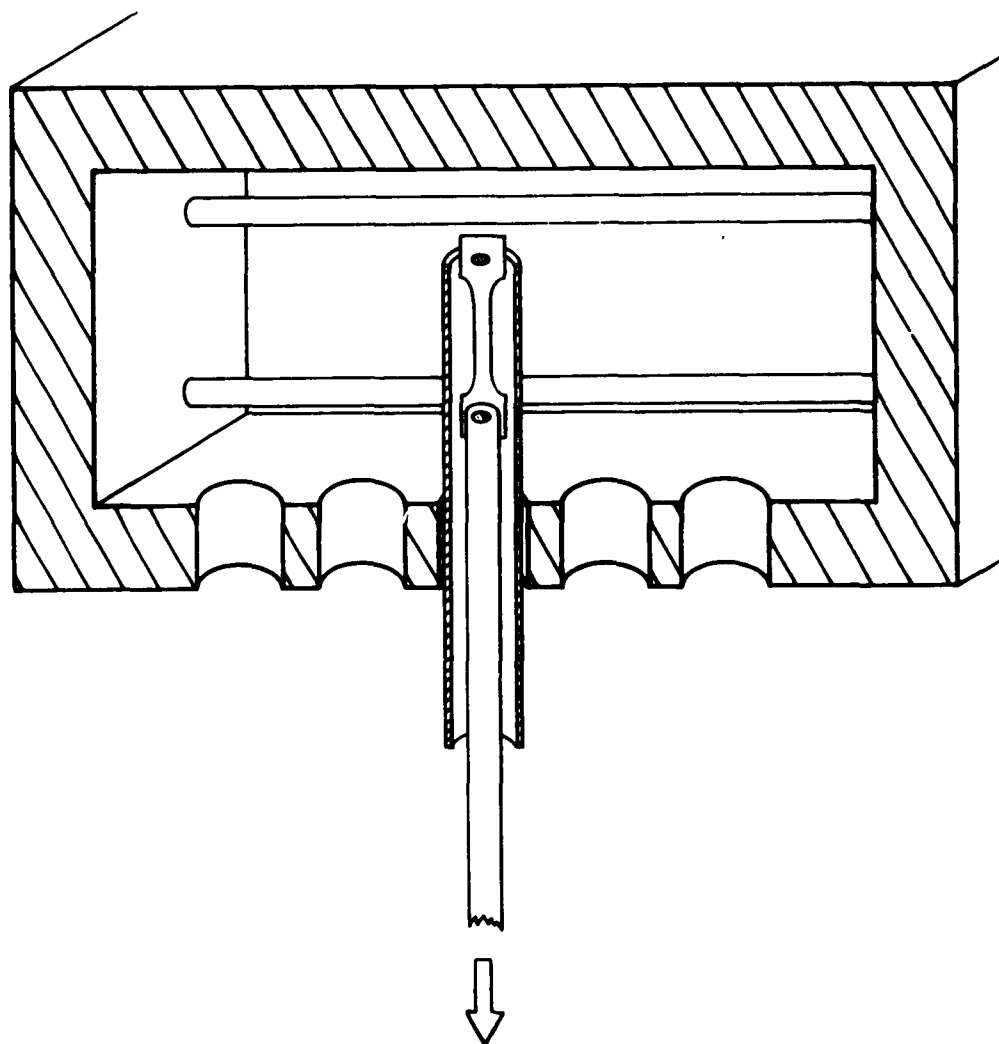
At 2300-2600°F the stress rupture tests were conducted in a multiple rack global heated furnace shown in Figure 45. Figure 46 is a photograph of the components of one of two stress rupture loading assemblies. The refractory tube and split support cap were both pure alumina. Cr-Ti-Si coated D-31 and D-41 columbium alloy pins were utilized for supporting the coated columbium alloy specimens.

Figure 45 Cross Section of the Hearth of a Globar Heated Multiple
Rack Stress Oxidation Furnace Approx. 1/3X

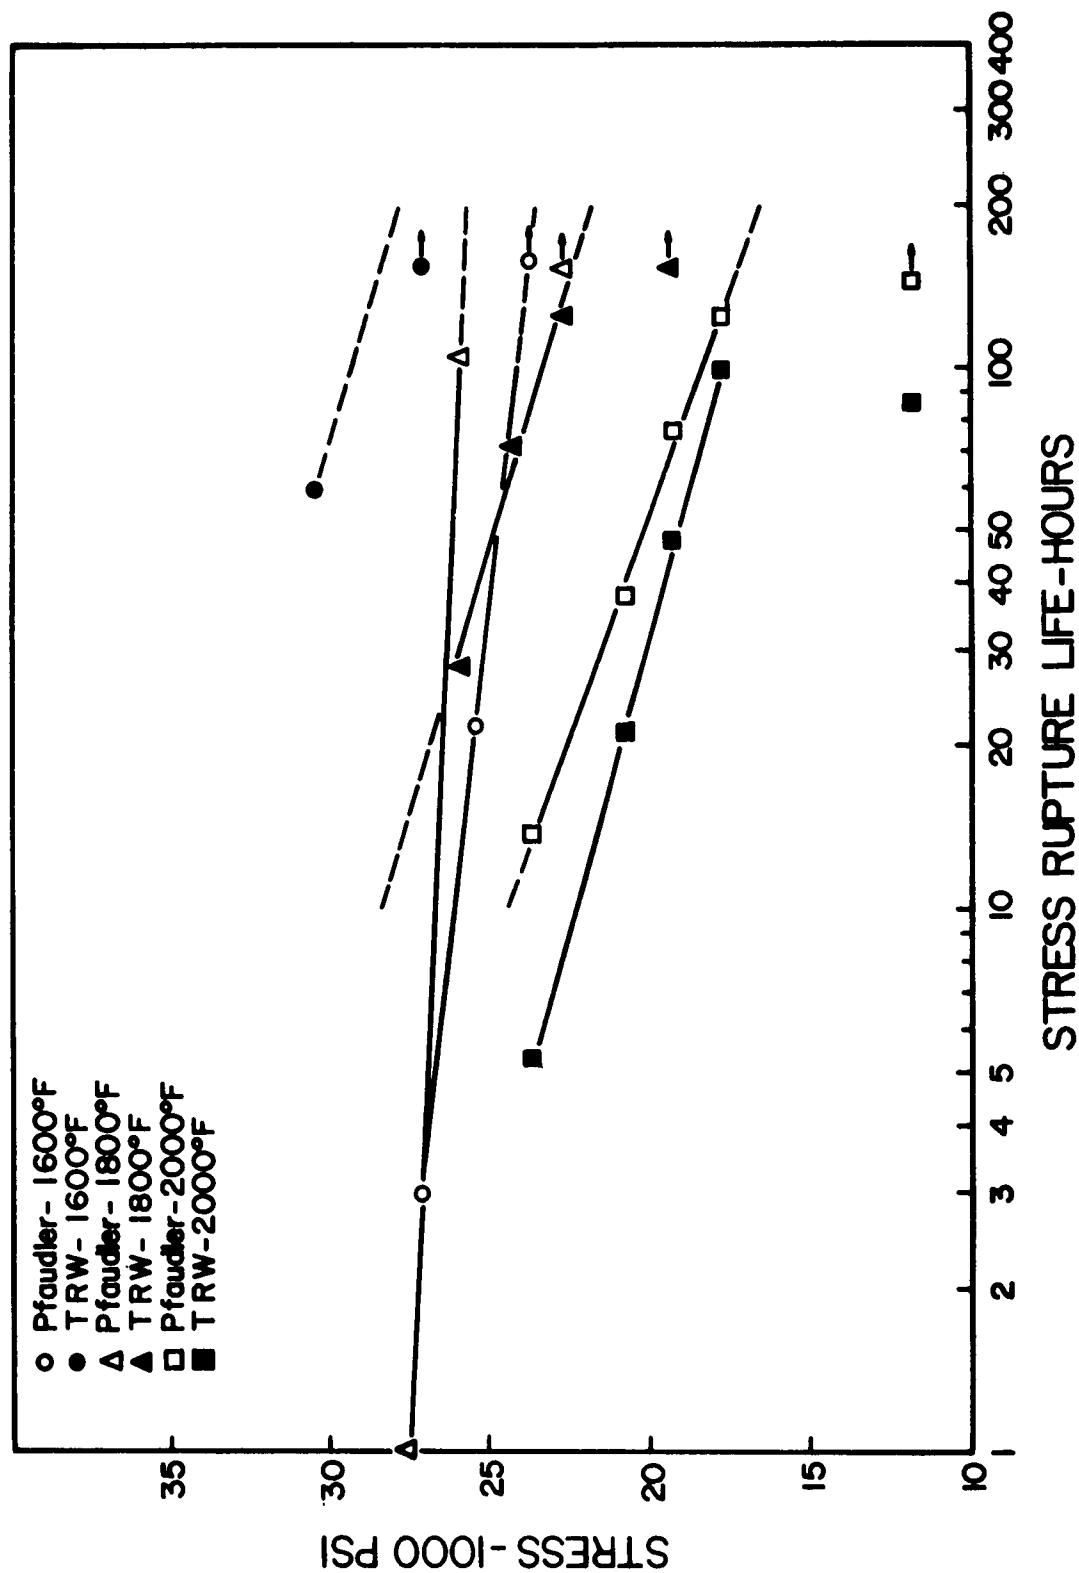
Figure 47 Stress Rupture Life as a Function of Stress for Pfaudler and TRW Coated FS-85 Alloy
Tested in Air at 1600-2000°F

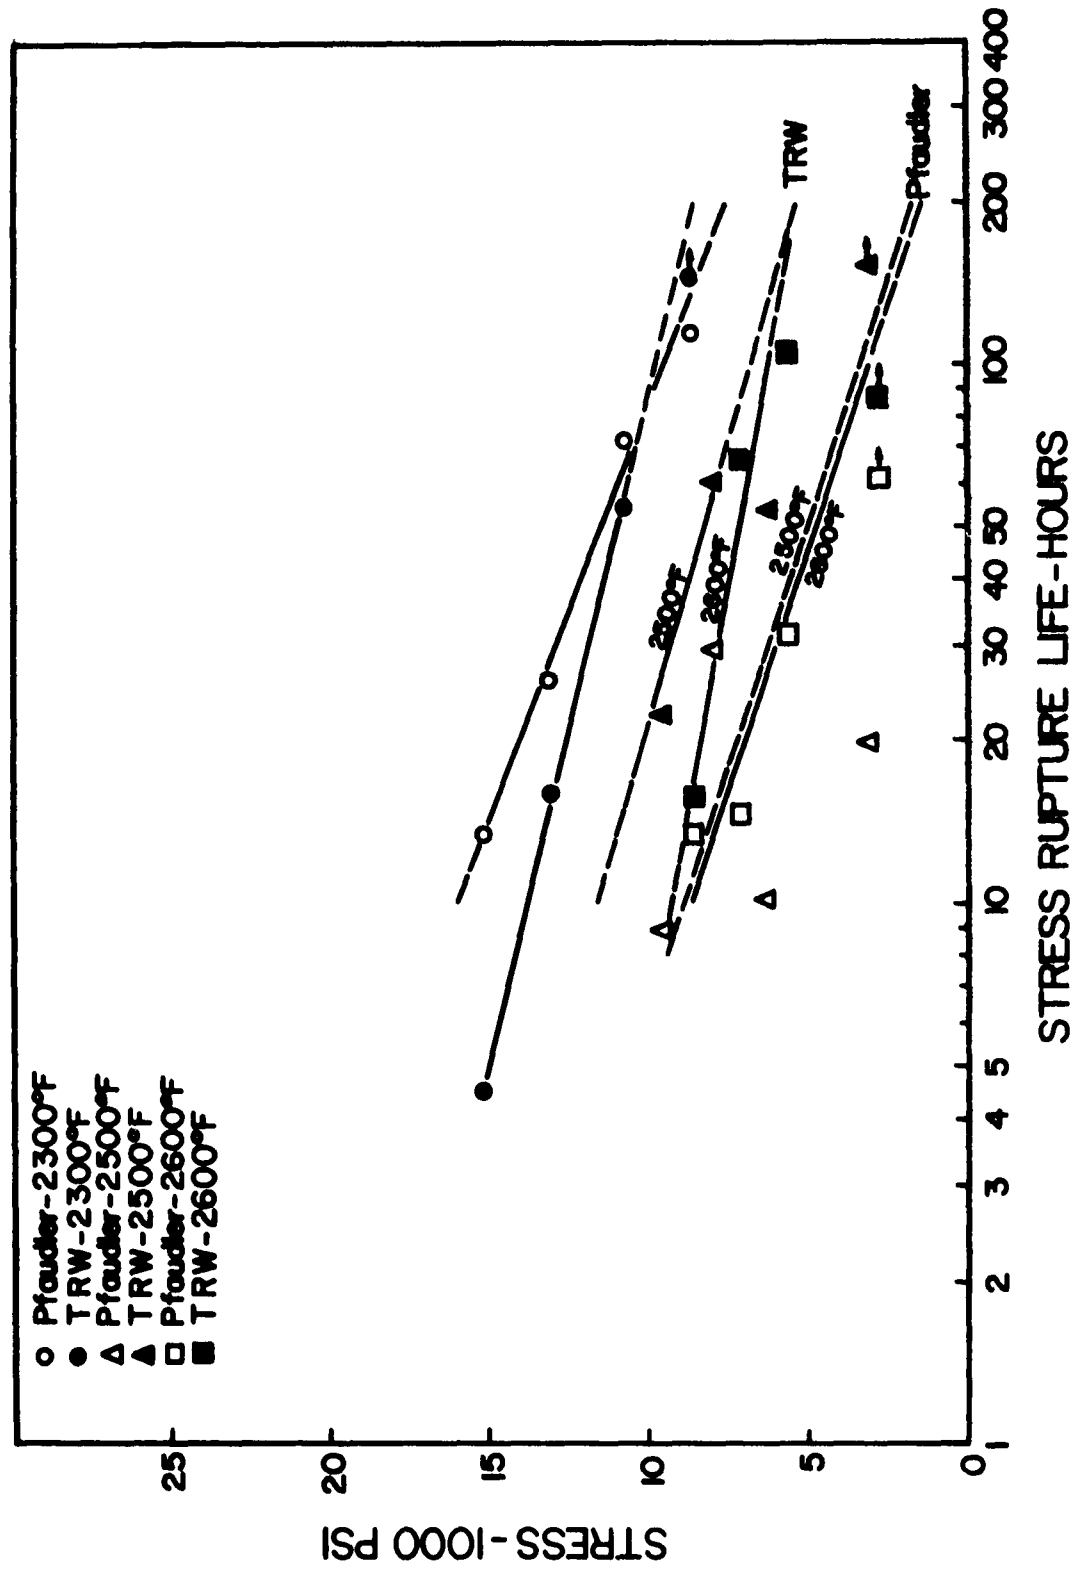
Figure 48 Stress Rupture Life as a Function of Stress for Pfaudler and TRW Coated FS-85 Alloy Tested in Air at 2300-2600°F

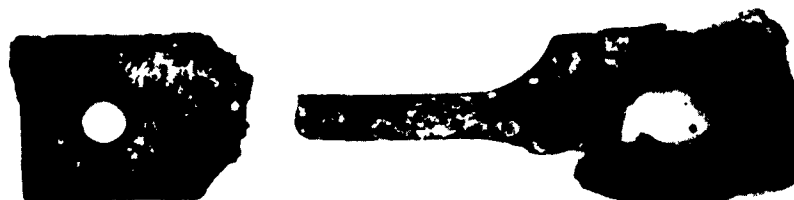
Figure 49 Pfaudler and TRW Coated FS-85 Alloy Specimens Stress Rupture Tested in Air at 2300 and 2500°F 1X

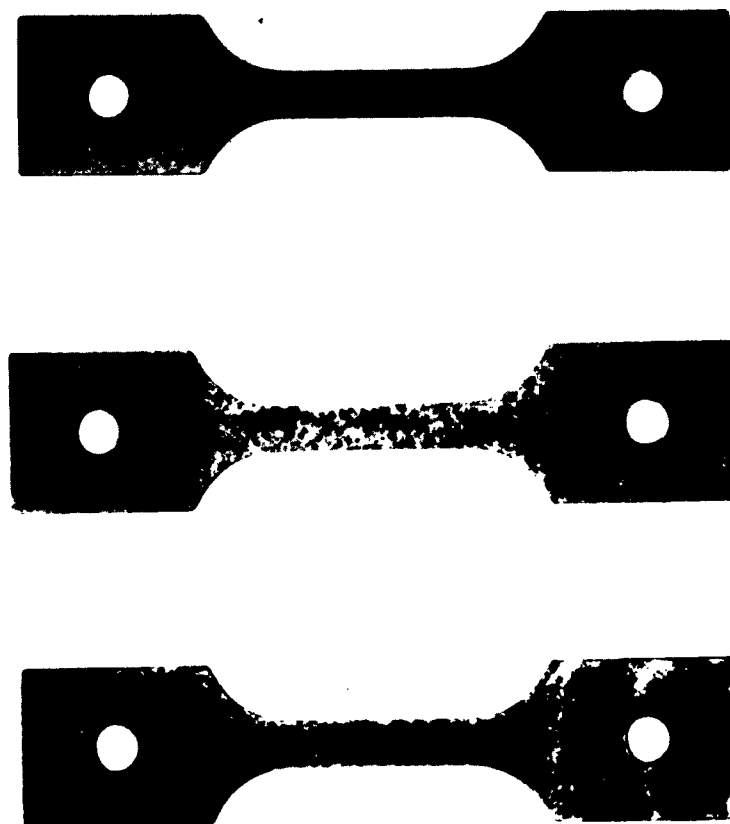
Figure 50 Pfaudler Coated FS-35 Alloy Stress Rupture Specimens Stress Oxidation Tested
Without Failure in Air at 1600-2000°F

Figures 50 and 51 are photographs of representative Pfaudler and TRW coated FS-85 alloy specimens which did not rupture after approximately 150 hours of stress oxidation exposure. Room temperature tensile tests were conducted on these and other specimens, which did not fracture in the stress rupture test, to assess the effect of

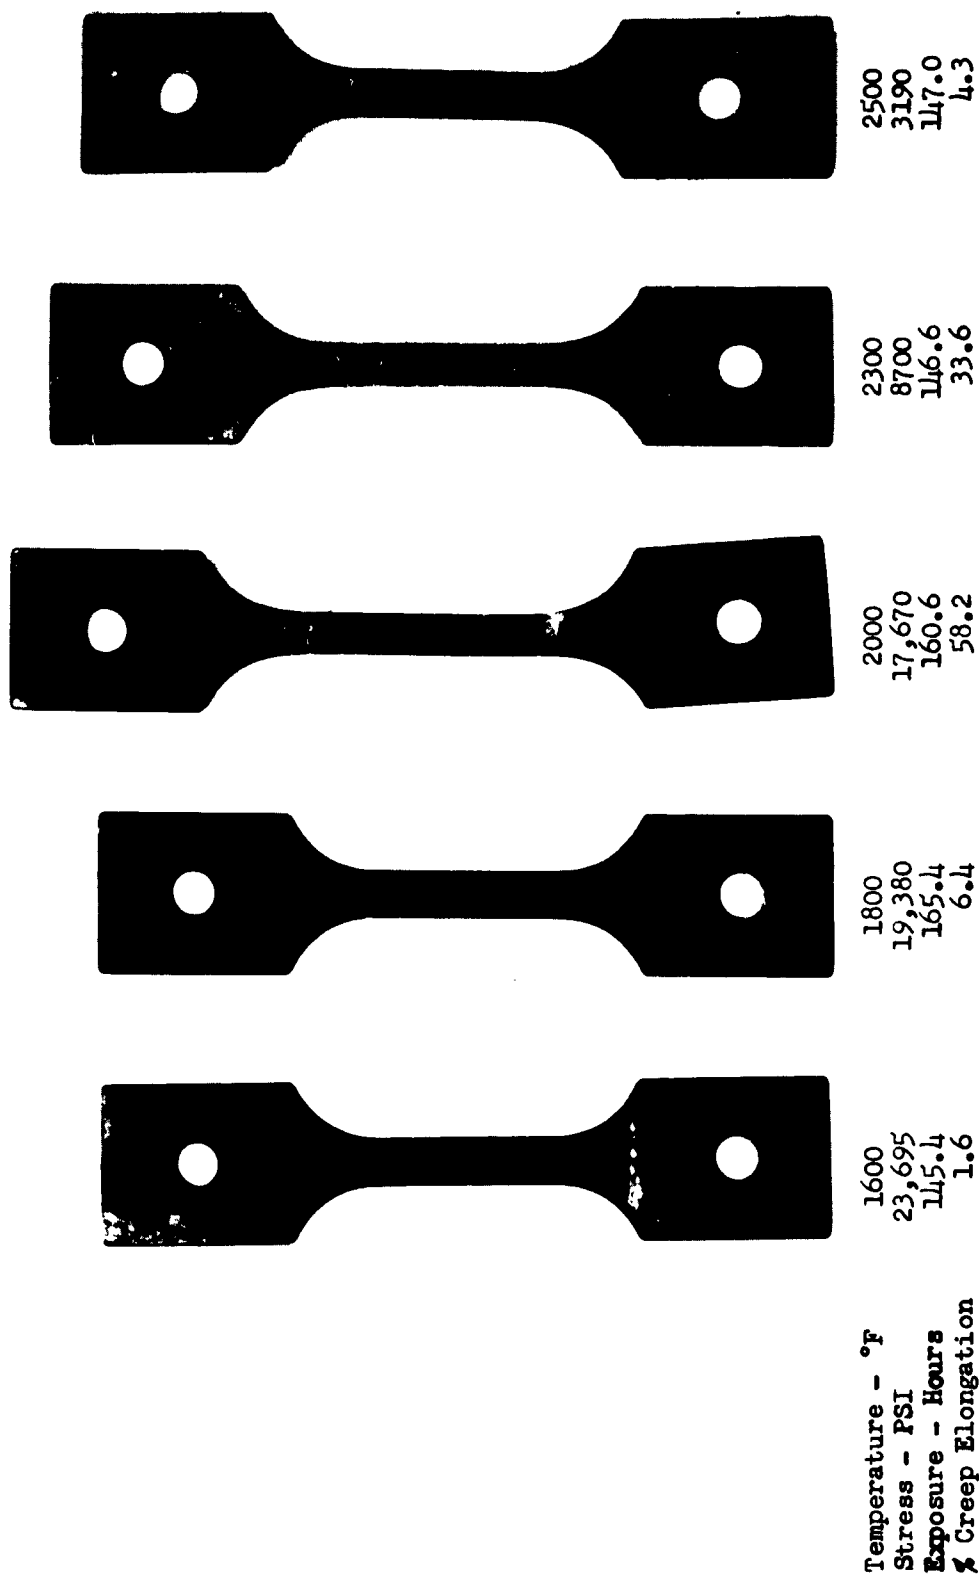
Figure 51 TRW Coated FS-85 Alloy Stress Rupture Specimens Stress Oxidation Tested Without Failure in Air at 1600-2500°F
